TELEVISION

SERVICING·PROJECTS·VIDEO·DEVELOPMENTS

January
1990

Vol. 40, No. 3
Issue 471

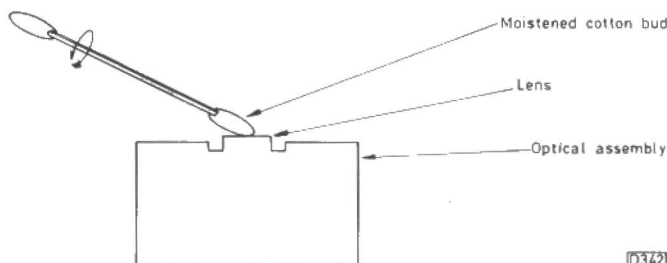
Fig. 1: Recommended method of cleaning a laser lens.

I've discussed cleaning the optical assembly with several engineers. Some use a fine soft brush while some use a soft cloth with some sort of cleaning liquid, all with varying degrees of success. It's difficult to clean anything without applying pressure, but too much pressure can damage the optical lens, rendering it useless. The safest method I know of is as follows.

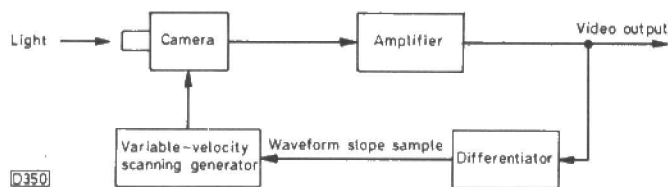
Fig. 6: Outline of a proposal for broadcast TV bandwidth compression based on the principle of varying the camera's scanning velocity automatically in accordance with the information rate (instantaneous slope) of the video waveform.

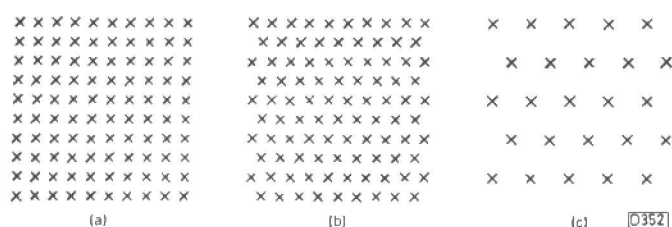
Fig. 8: Subsampling patterns used for HD-TV bandwidth compression. (a) An orthogonal pattern. (b) An offset (quincunx) version of (a). The coarser quincunx pattern shown at (c), using a lower subsampling rate, results in a reduced bandwidth requirement.

Fig. 8 shows at (a) a conventional orthogonal sampling pattern applied to a picture and at (b) the corresponding offset or quincunx pattern. The term quincunx refers to the repeated arrangements of five samples, like the five dots on one face of a gaming die, that can be discerned in this pattern. The quincunx method of sampling improves

the horizontal and vertical resolution relative to orthogonal sampling but reduces the diagonal resolution. It's possible therefore to use a coarser quincunx pattern as shown at (c). This coarser pattern provides the original horizontal and vertical resolution, corresponding to (a), while giving reduced diagonal resolution. Since the eye is relatively insensitive to diagonal detail this loss due to the sampling action doesn't matter. The system uses diagonal filtering to obtain this diagonal sampling loss. The result, as shown at (c), is a sampling pattern with half the number of samples for a given area of picture. This of course means that the sampling rate is halved. Accordingly this process reduces the bandwidth requirement by a factor of two.

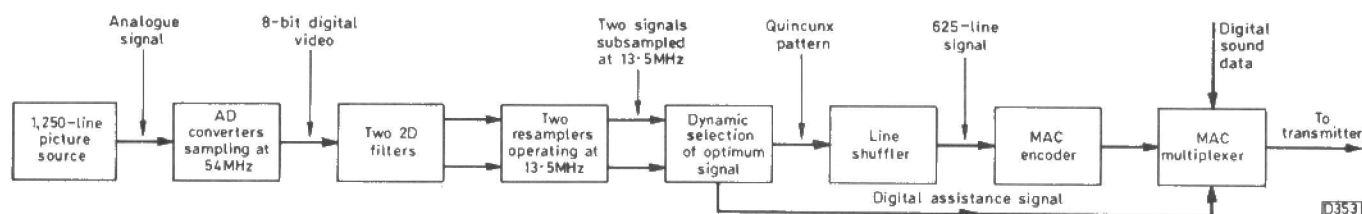
Fig. 9: Block diagram showing the main signal processing arrangements used for bandwidth compression in the Eureka 95 compatible HD-TV system. For simplicity only the luminance chain at the transmitting end is shown – this is the most critical part of the system for image resolution.

The Eureka 95 system compresses the bandwidth by taking a longer than normal time to transmit the samples that comprise one complete picture, spreading them over four fields. This affects picture quality. It gives no trouble in static parts of the picture, but in moving parts it causes loss of resolution or blurring. This is obviously not acceptable for HD-TV purposes. The Eureka system has to use additional signal processing therefore to combat this impairment where movement is present. In the provisional system demonstrated at Brighton in September 1988 a motion-adaptive method of encoding is included to mitigate the problem.

In stationary areas of the picture this technique uses the four fields of samples to construct an image with high spatial resolution but poor temporal resolution. In moving areas it uses one field of samples to construct the

picture, the result being reduced spatial resolution but good temporal resolution. Whichever of these modes gives the better result at a given moment is selected automatically by the motion-adaptive system.

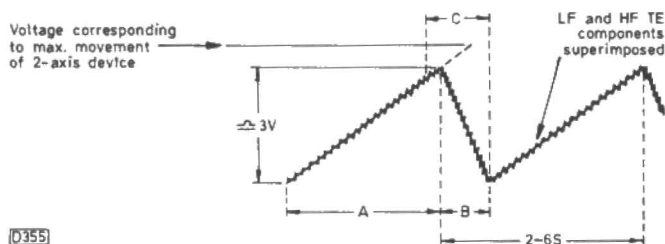
Fig. 2: Waveform at the emitters of Q204/5 in Fig. 1.

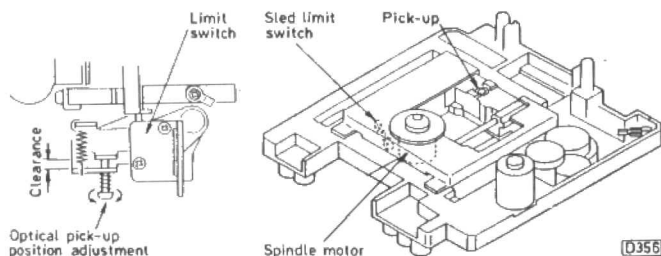
Fig. 3: Example of a limit switch used to set the initial position of the sled. On early models the switch was adjustable: the setting is critical.

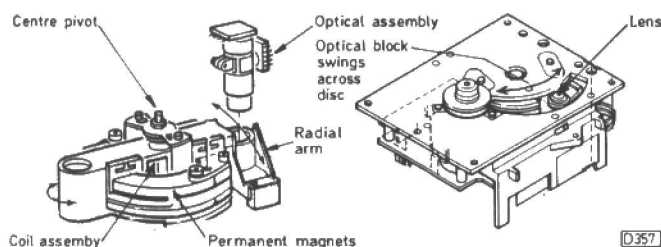
Fig. 4: The Philips radial tracking arm mechanism.

radial arm to a normal record player tone arm that tracks continuously across a disc and the sled and coil action to a linear tracking record player arm that crabs its way across the disc.

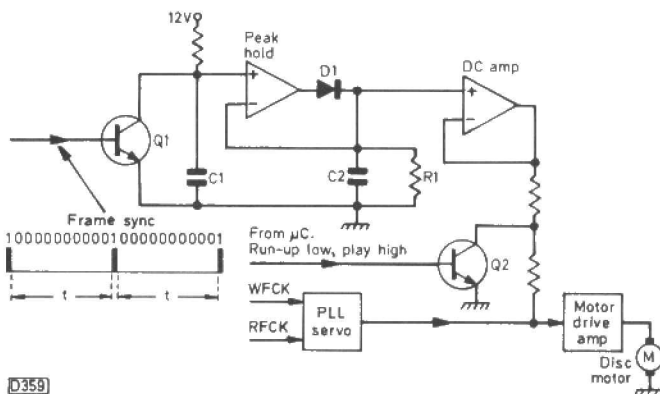
Fig. 6: Operation of the disc run-up servo.

We'll consider first the rough servo, which is more often referred to as the speed or run-up servo. The principle is shown in Fig. 6 (this particular example is taken from the earlier Sony Model CDP101). To start things off the servo gives the motor a brief "kick" – this lasts for about 0.3sec. As a result the disc begins to rotate slowly. Once this happens data can be read off the

disc, though its rate will be too slow for the decoder to be able to interpret it. The regular frame sync signal with its very distinctive 10000000000100000000010 pattern will be recognisable however (remember that, as pointed out in Parts 6 and 8, the frame period is the only time when ten consecutive zeros occur).

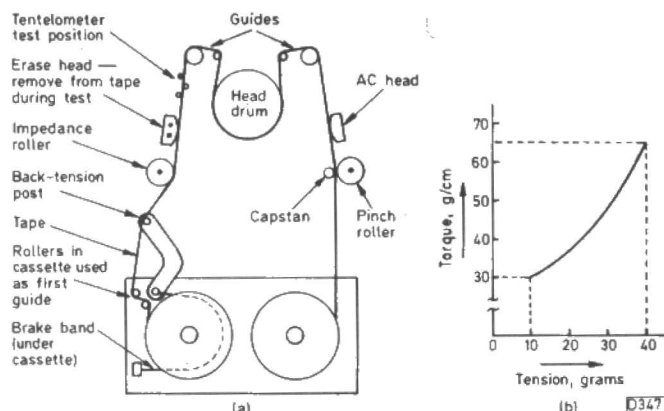
Fig. 1: (a) Typical Panasonic deck mechanism, simplified, showing the back-tension arrangement. (b) Conversion for tension/torque measurements with the D1 deck - 40-45g/cm is the correct back tension (torque).

In the August 1988 article I quoted back tension for various Panasonic machines and showed a typical VHS deck layout. Deck designs vary, as we've seen, but Philips has come up with a mechanism that differs radically from the usual arrangement. It's used in the Philips VR6467 and various clones such as the Pioneer VR707 and the B and O VHS82. Back tension is altered in two ways with this design. First, by what's called "dynamic tape tension", and secondly by supply-reel friction. Both of these should be checked in cases where you'd normally check the back tension.

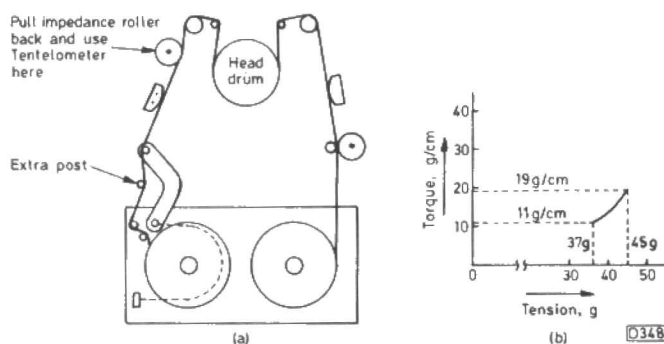
Fig. 2: (a) Typical Ferguson/JVC mechanism. (b) Tension/torque conversion for the 3V55.

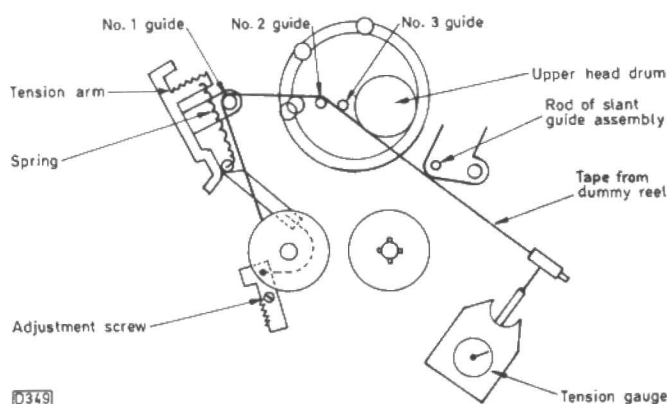
Fig. 3: Video-8 back-tension measurement. You use a fan-type tension gauge and dummy reel.

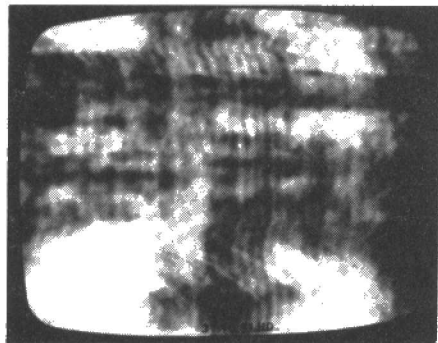
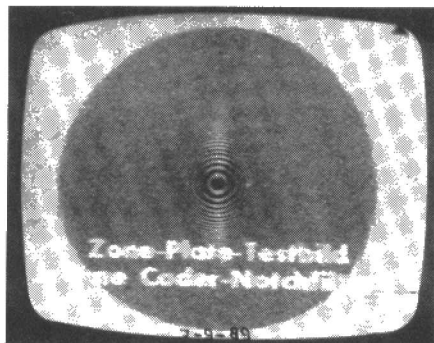
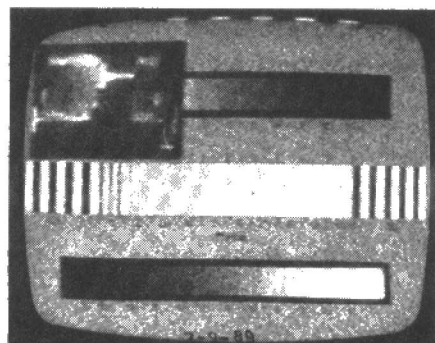
Left: An example of "good-quality" F2 reception. Note the multiple images. F2 pictures are generally smeary with reduced h.f. content. Centre: A test pattern transmitted by Hamburg ch. E9 for receiver alignment purposes. Right: Another test pattern transmission from Hamburg ch. E9. All photos are of reception by Ryn Muntjewerff in Holland.
